4. I-5 Test Evaluation

4.2 I-5 Test Locations

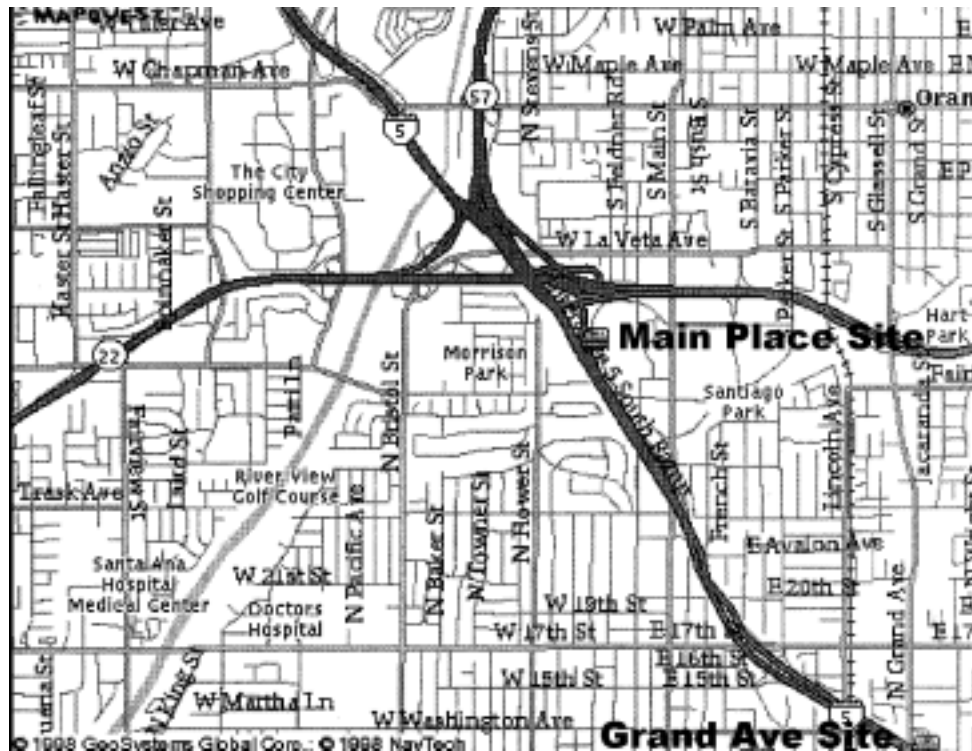
Figure 4-1. Main Place and Grand Avenue evaluation site locations along I-5

The maps in Figures 4-1 through 4-3 show the locations of the six surveillance trailers at Main Place, Grand Avenue, First Street, Tustin Ranch Road, Jamboree Road, and Culver Drive evaluation sites in north to south order along I-5. All, but the First Street trailer, were on the northbound side of the freeway. The relay site that retransmitted video and data from the surveillance trailers to the TMCs at Caltrans District 12 and Anaheim and to the ITS Laboratory at UCI is also indicated in Figure 4-2. During the evaluation, the trailers were powered from liquid propane fueled generators and storage batteries. The only

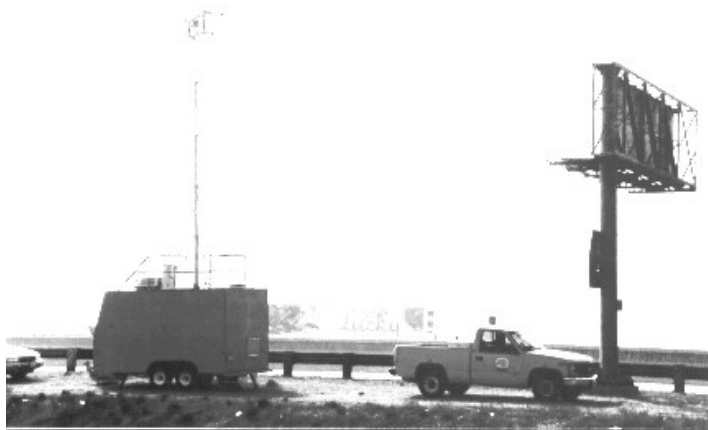
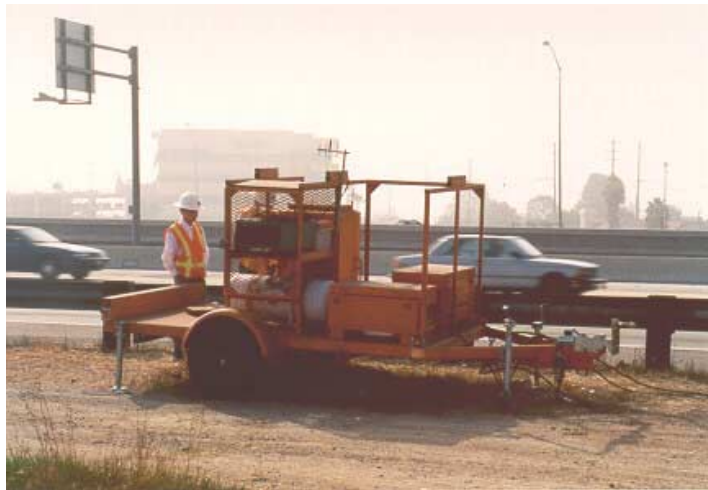
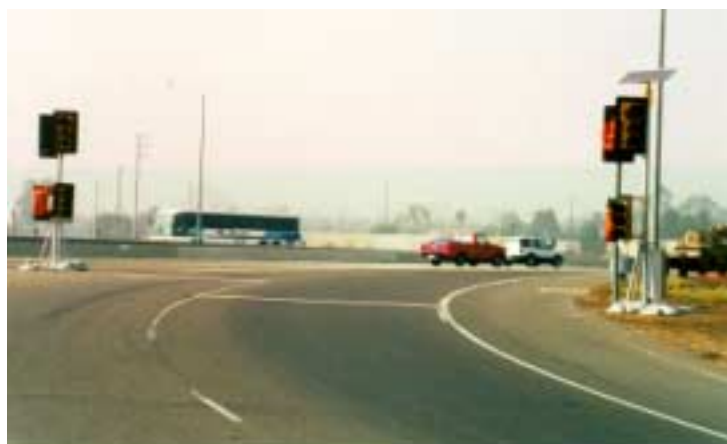
Figure 4-5. Surveillance and ramp meter trailers and signals at Grand Avenue

(a) Surveillance trailer

(b) Ramp meter trailer

(c) Ramp signals

The meter-on sign at Jamboree Road in Figure 4-9 is covered because it was not operational at the time this photograph was taken. The portable signal heads were placed in front of the permanent ones, which were covered to prevent confusion. Figures 4-11 to 4-16 contain layouts of the surveillance and ramp meter trailer placement at the six locations. Grand Avenue was the only site to use two ramp meter signal heads.

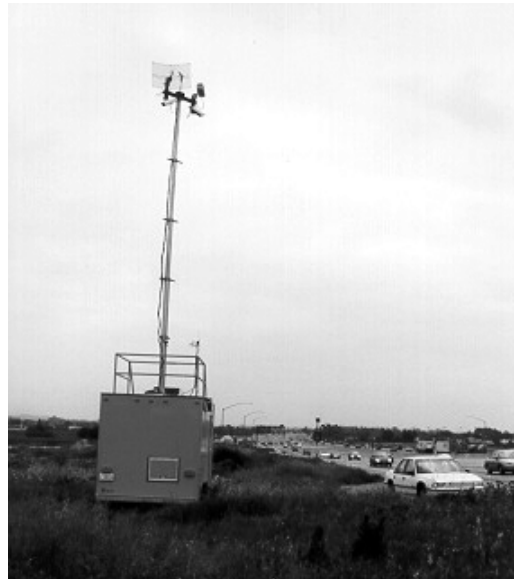
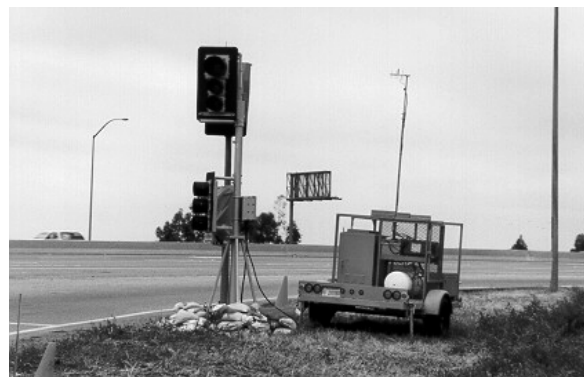
Figure 4-8. Surveillance and ramp meter trailers at Jamboree Road

(a) Onramp with surveillance trailer on left, ramp meter trailer and signal on right

(b) Surveillance trailer alongside of I-5 freeway

(c) Ramp meter trailer and signal

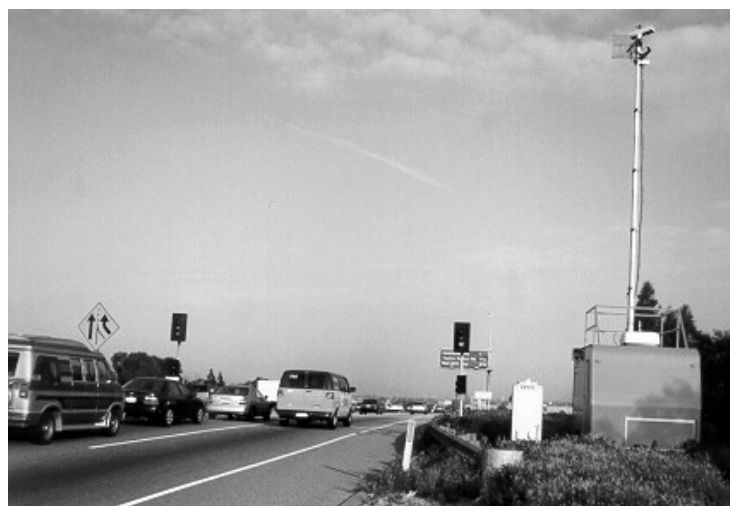
Figure 4-10. Surveillance trailer at Culver Drive

(a) Trailer and tow truck

(b) Trailer in position with mast extended

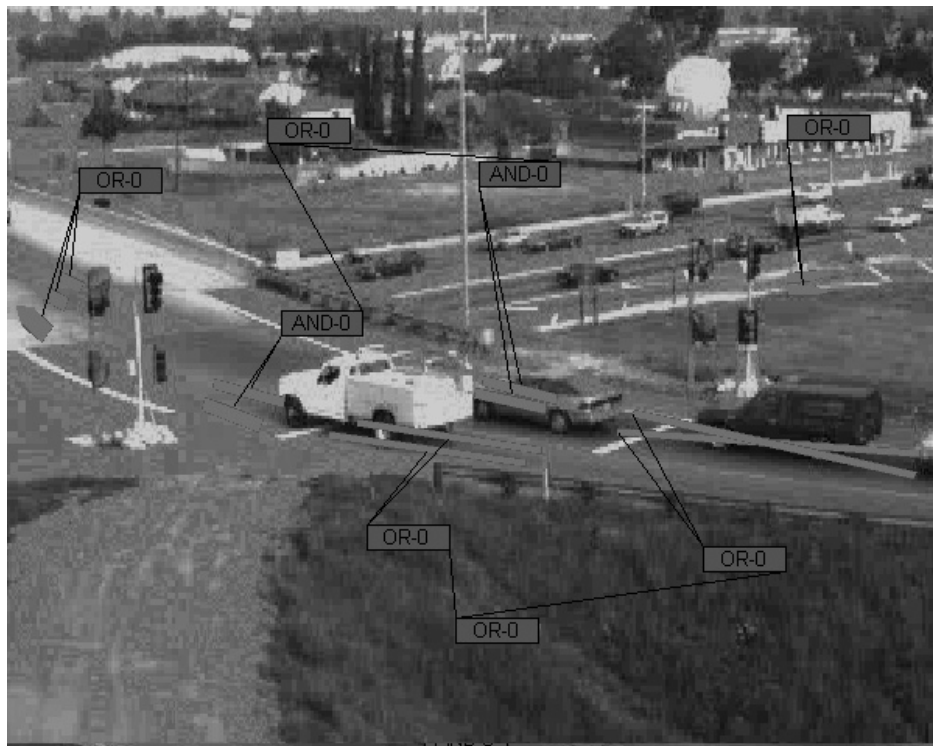
Figure 4-17. Mainline and ramp AutoScope detection zones at Grand Avenue

Figures 4-17 through 4-19 show the AutoScope 2004 VIP detection zones on the mainline and onramp at the three ramp meter evaluation sites. These images were downloaded from the supervisory computer used to configure the detection zones. On the mainline, count detectors were connected by AND logic to reduce false counts caused by image projection from vehicles into more than one lane. This was a noticeable problem brought on by the relatively low camera height and side-viewing geometry. Econolite placed speed (the long rectangular detection zone), presence, and demand detectors in the Grand Avenue mainline field of view to demonstrate the different options available for vehicle detection. The detectors used at Grand Avenue during the FOT are those on the left and upper portion of the image connected by AND logic. The detection zones on the ramp consisted of demand detectors. These detectors were connected by OR logic to increase the probability of vehicle detection by the VIP and the consequent change of signal from red to green. In addition to detectors parallel to traffic flow, detectors were configured in the shape of an X on the ramps to increase the probability that a vehicle was detected.

(a) Mainline detection zones

(b) Ramp detection zones

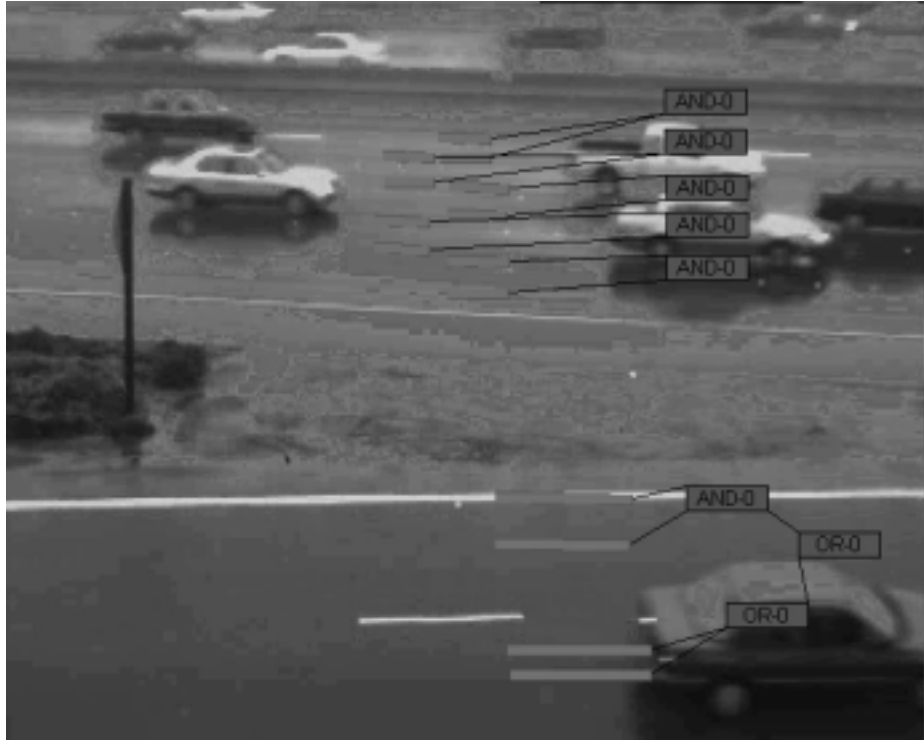
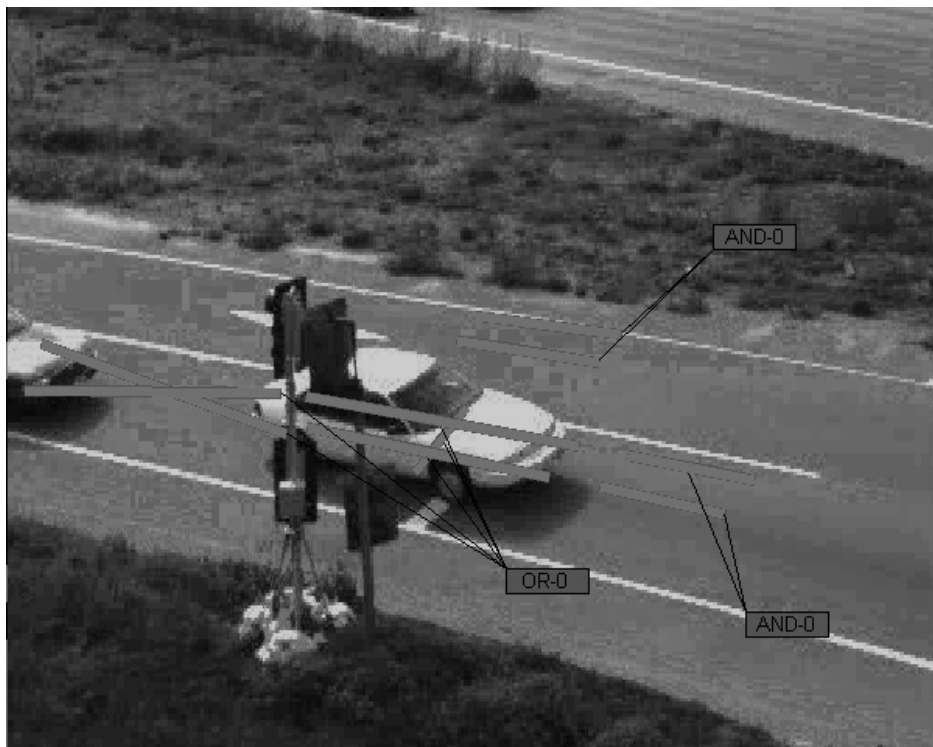
Figure 4-18. Mainline and ramp AutoScope detection zones at Tustin Ranch Road

(a) Mainline detection zones

(b) Ramp detection zones

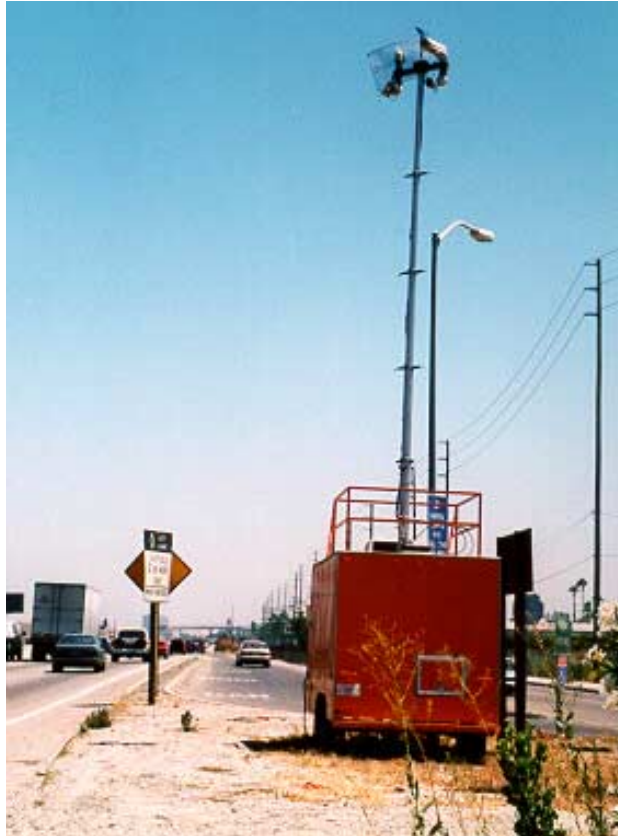
Figure 4-25. Surveillance trailer location at southbound entrance to I-5 at Katella Way

Eventually a surveillance trailer was brought to Katella Way and I-5 as shown in Figure 4-25. The intent was to gather information about the trailer's use in an actual construction area. The Caltrans District 12 TMC personnel periodically ensured that the cameras and their scanning controls were operational, but did not really use the video imagery in traffic operations. It is believed, however, that the imagery from the cameras would have been used if an emergency developed in the area surveilled by the cameras.

(a) Rear view of trailer showing southbound I-5 and entrance ramp

(b) Katella Way entrance ramp showing surveillance trailer to left of ramp
